REPORT NAME: PFS-17101 Tuned Exhaust System Installation Instructions and
Instructions for Continued Airworthiness.

REPORT NUMBER: PFS-17160-00

AIRCRAFT APPLICABILITY: Robinson R22 Series Equipped with O-320-B2C Engines

STC NUMBER: SR03863AT

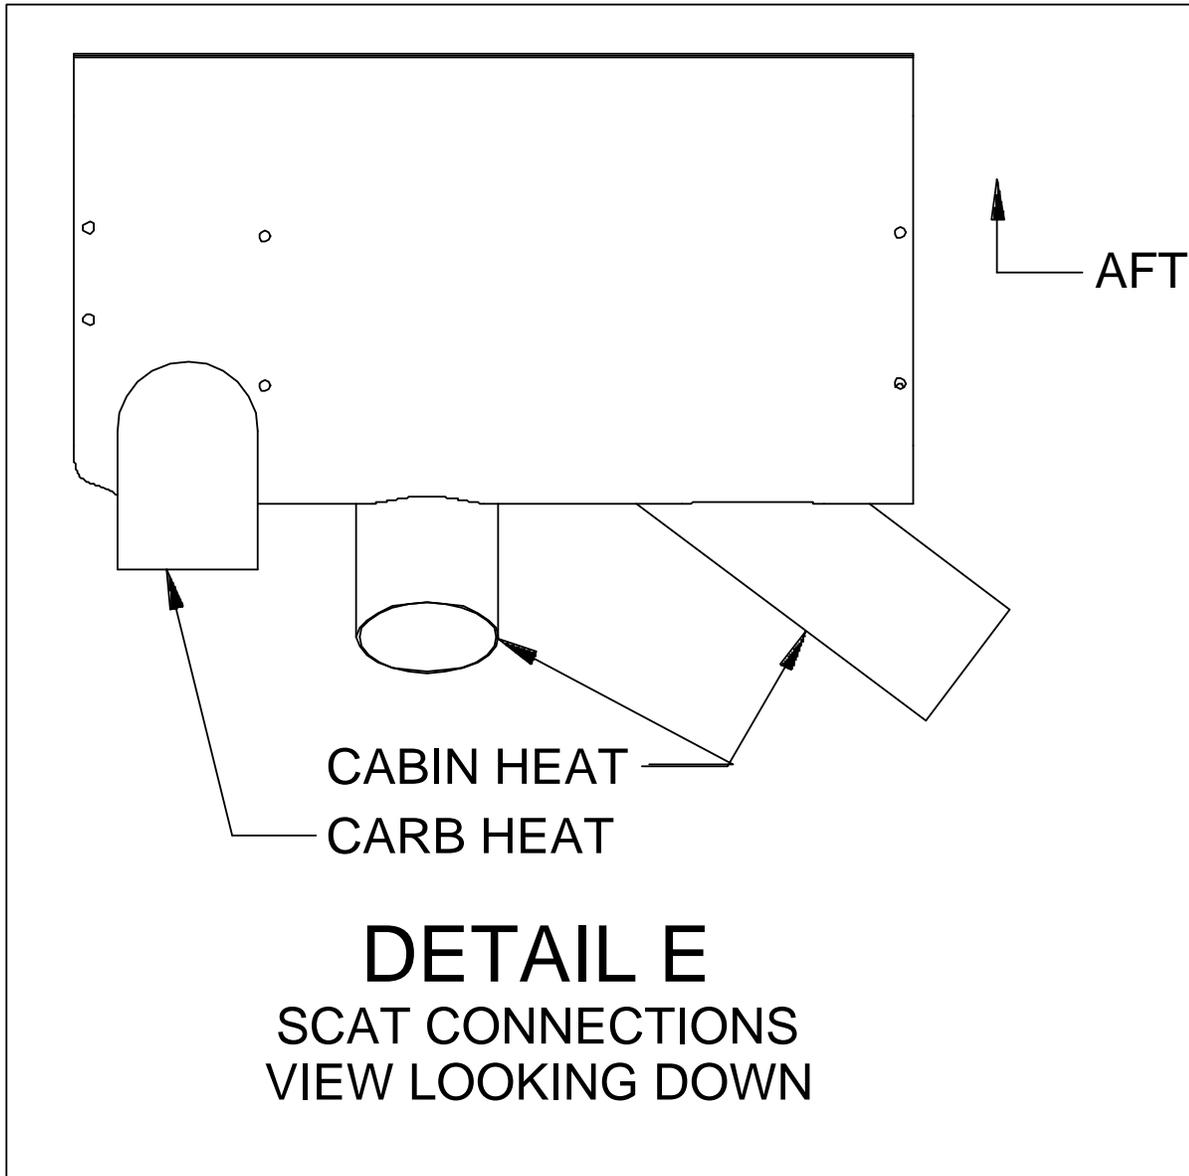
DETAIL E – SCAT Tube Connections

Combination shroud (50710) shown. When cabin heat is not installed or not regularly used, the Carb Heat Only Shroud (51711) must be installed. The Carb Heat Only shroud can be identified by the large cutout exposing the collector tubes and lack of cabin heat flanges.

- 4.1.5 Attach SCAT hoses to shroud sub assembly (50710 or 50711). The carb heat flange is the 90-deg mitered tube. If the cabin heat system is not installed or not regularly used, ensure that P/N 50711 carb heat shroud is installed, rather than the 50710 combination shroud; failure to do so may cause the collector tubes to overheat and shorten the lifespan of the exhaust system. See Detail E.
