Installation Instructions and
Instructions for Continued Airworthiness
Kit: PFS-13706

REPORT NAME: PFS-13706 Tuned Exhaust System Installation Instructions
and Instructions for Continued Airworthiness
REPORT NUMBER: PFS-13752-00
REVISION: E
REPORT DATE: March 26, 2014
AIRCRAFT APPLICABILITY: Cessna 177RG (Cardinal RG)
Cessna F177RG (Reims)
PREPARED BY: D. TILMAN
DISTRIBUTION: FAA ATL ACO, END USER
STC NUMBER: SA03623AT

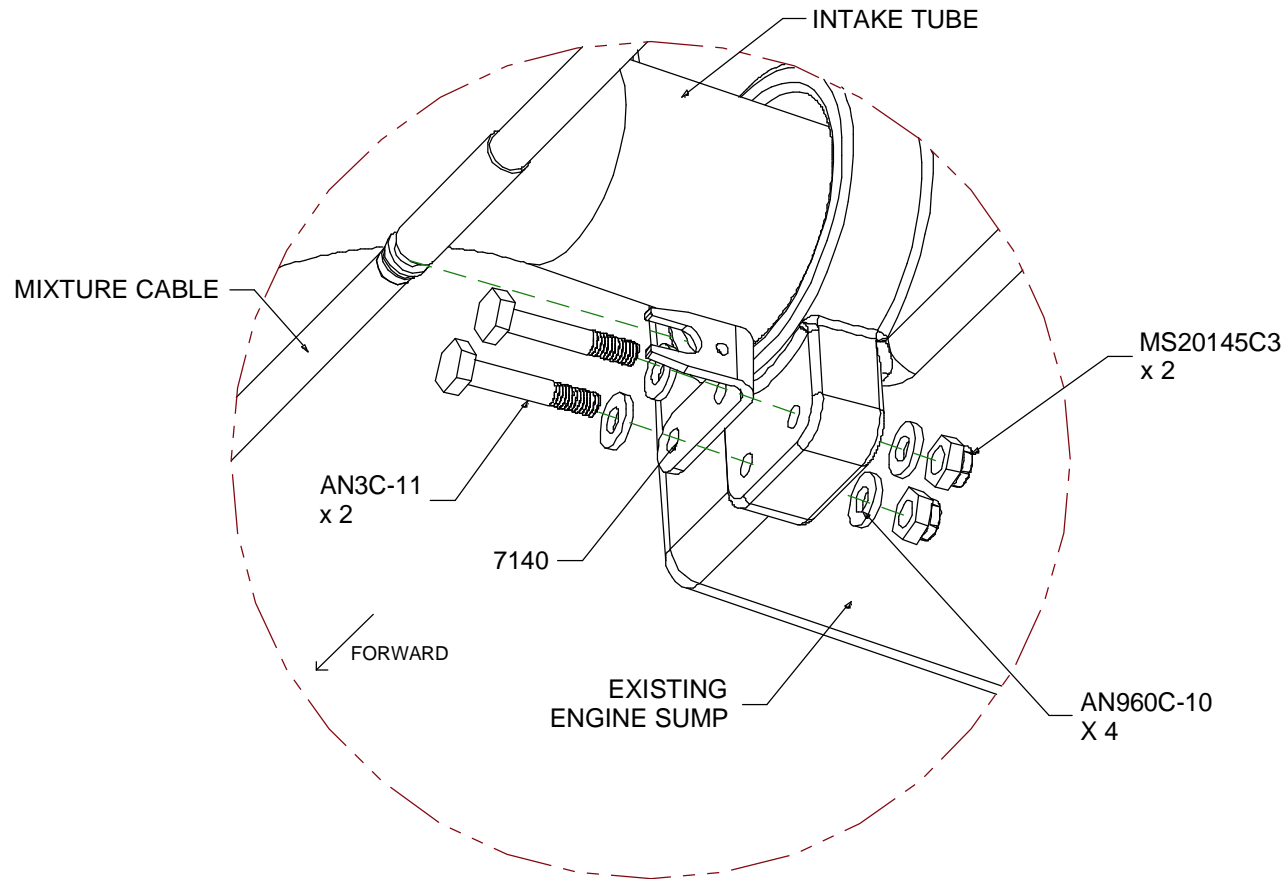
DETAIL B

MIXTURE CABLE BRACKET INSTALLATION
EQUIVALENT HARDWARE MAY BE USED THROUGHOUT
MIXTURE CABLE IS TO BE SECURED WITH SAFETY WIRE (NOT SHOWN)

- 3.2 – Replace mixture cable attach bracket on the engine sump with the enclosed P/N 7140 using the existing hardware. See Detail B.
- 3.3 – If your aircraft has a straight manifold drain valve (often referred to as a “sniffle” valve), you may need to replace it with an angled valve for exhaust system clearance.

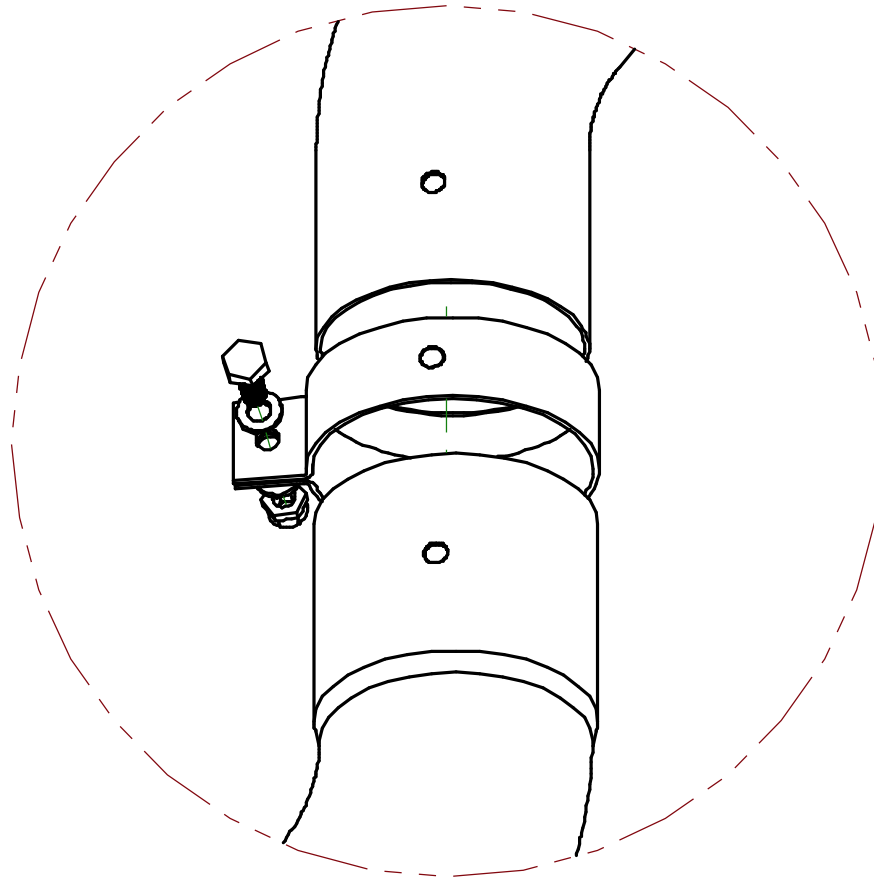
DETAIL E

TAILPIPE DETAIL

- 4.2.8 – Install the tailpipe and pinned clamp (P/N 7025) through the hole drilled in step 4.2.5. Install using AN4C5A Bolt, two AN960C416 washers, and one MS21045C4 locknut. See Detail E.

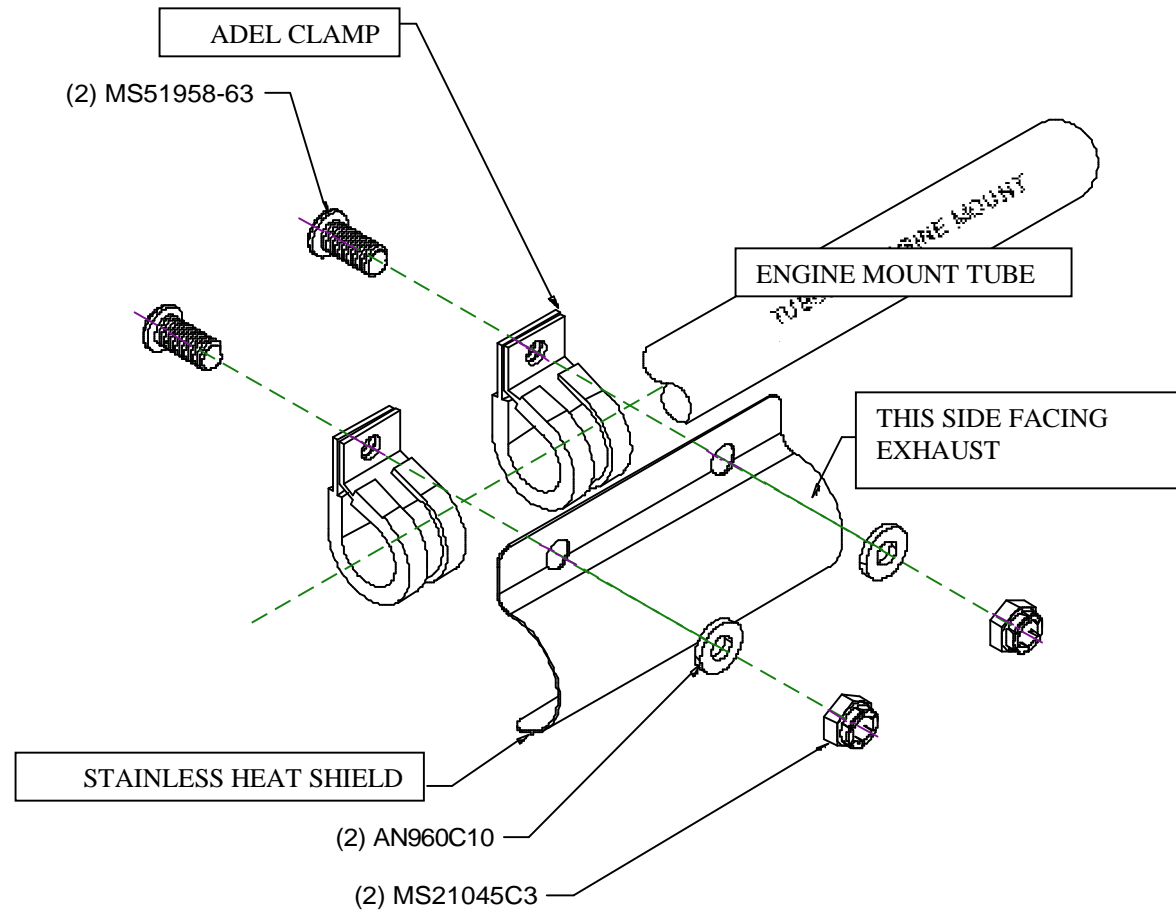
DETAIL F

HEAT SHIELD INSTALLATION

- 4.2.3 – Install heat shield (2001) between intermediate tube and engine mount tube at the point of closest approach. See Detail F.
- 4.2.4 -- Install the 8033 clamp and the 7026 clamp as shown in Detail D (twist tab on 8033 clamp as required). Ensure that you will have positive clearance between the intermediate tube and the engine mount heat shield. If you do not have positive clearance, you can loosen the clamps and then reposition the intermediate tube to ensure positive clearance to the engine mount. Once the intermediate tube is repositioned, you can tighten the 8033 clamp and the 7026 clamp as appropriate.

- 5.3 – Verify that you have positive clearance between the intermediate tube and the engine mount heat shield at the point of closest approach. See Detail F.
